## f-POD ECO – Error 05

Error 05 is a weighing Range error and can be caused by several reasons as listed below

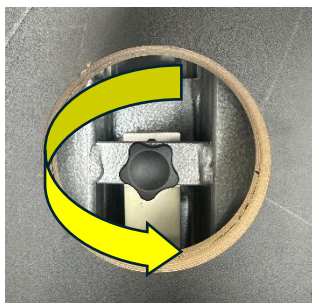
- 1: Travel Stop Screw has not been released – Locate the Travel Screw under the machine and make sure it is full unwound in an anti-clockwise direction
- 2: Bowser tank is over filled – This can be caused if once the bowser has stopped after being filled, the hoses are left connected so siphoning can occur allowing an overfill to occur.

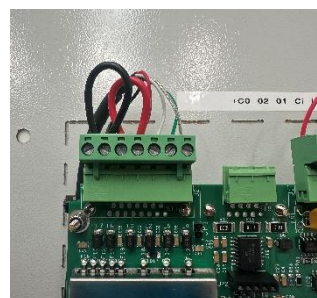
Loadcell Connection

- 4: Check the Loadcell Connector and its individual wires for tightness on the main control circuit board on the inside of the bowser control box. The loadcell connector is the one with 7 small wires on the top left of the PC
